# **Fisheries Resources in White Pine County**

**June 22, 2013 Update  
to the  
Nevada Board of Wildlife  
Commissioners**

**Jon C. Sjöberg  
Chief of Fisheries**

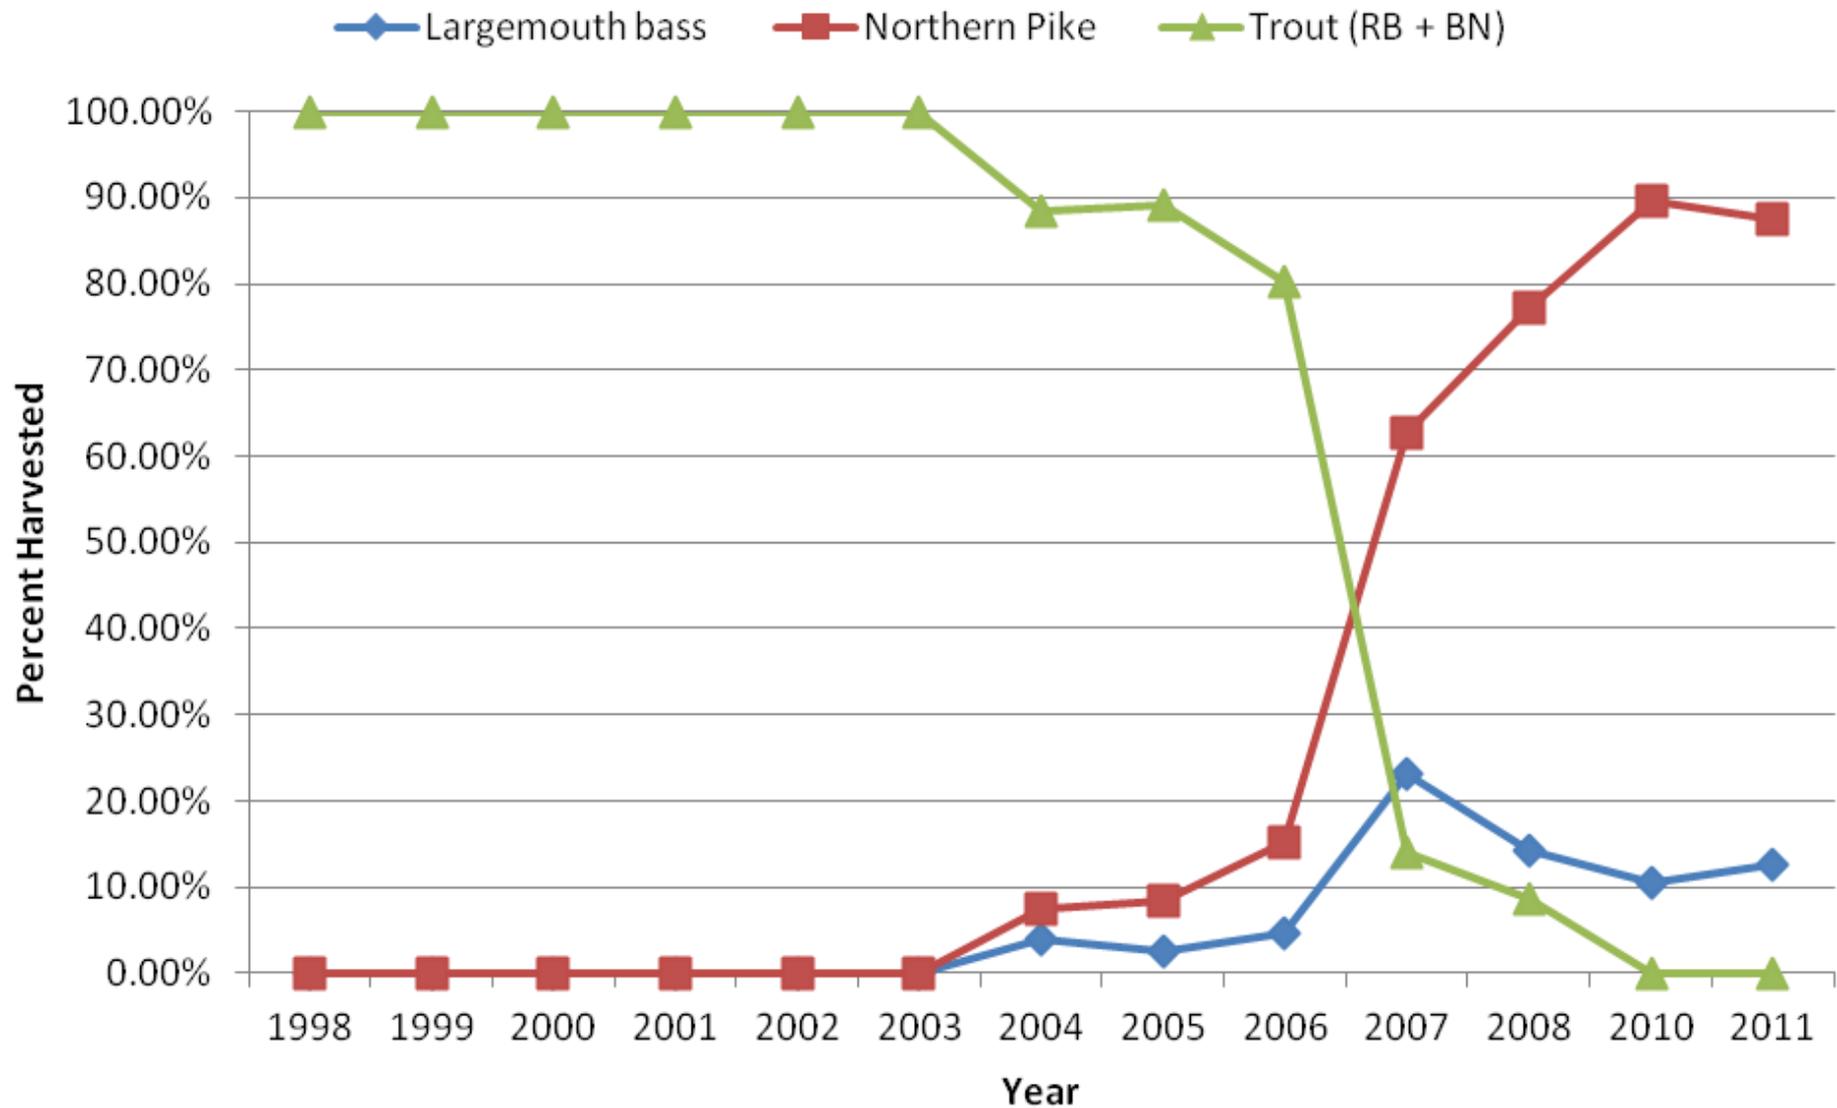
## % Composition of Fish Harvested by Year

# Comins Lake

**Electroshocking surveys document the effective elimination of trout by fall, 2008.**

**Largemouth bass reproduction effectively eliminated by fall, 2009.**

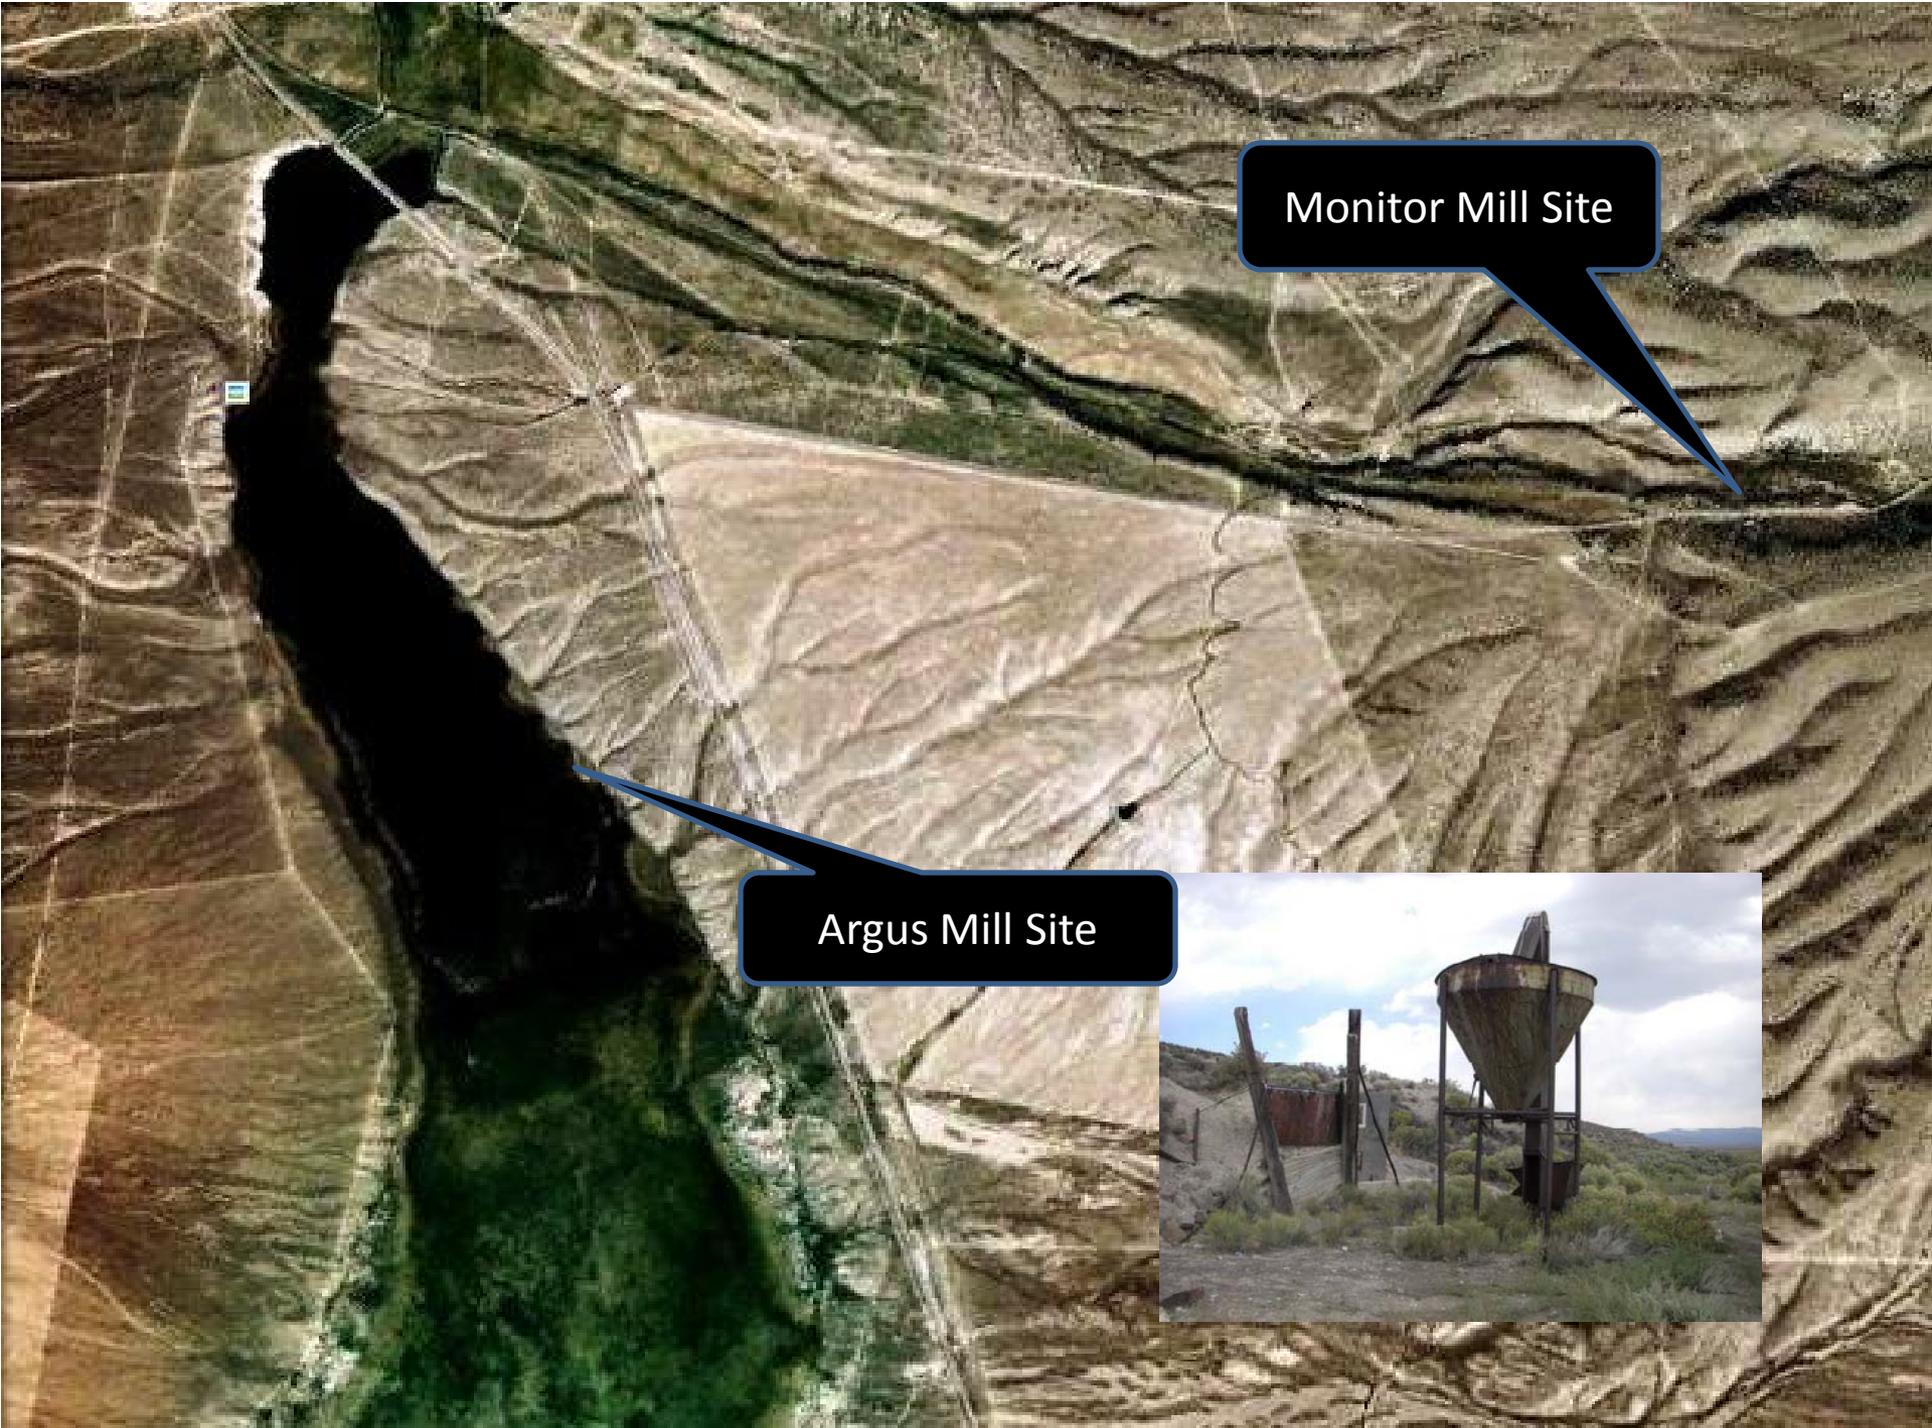
**Preliminary soil sampling in 2007 by NDEP and the EPA identified two possible sources of mercury.**

Monitor Mill Site

Argus Mill Site

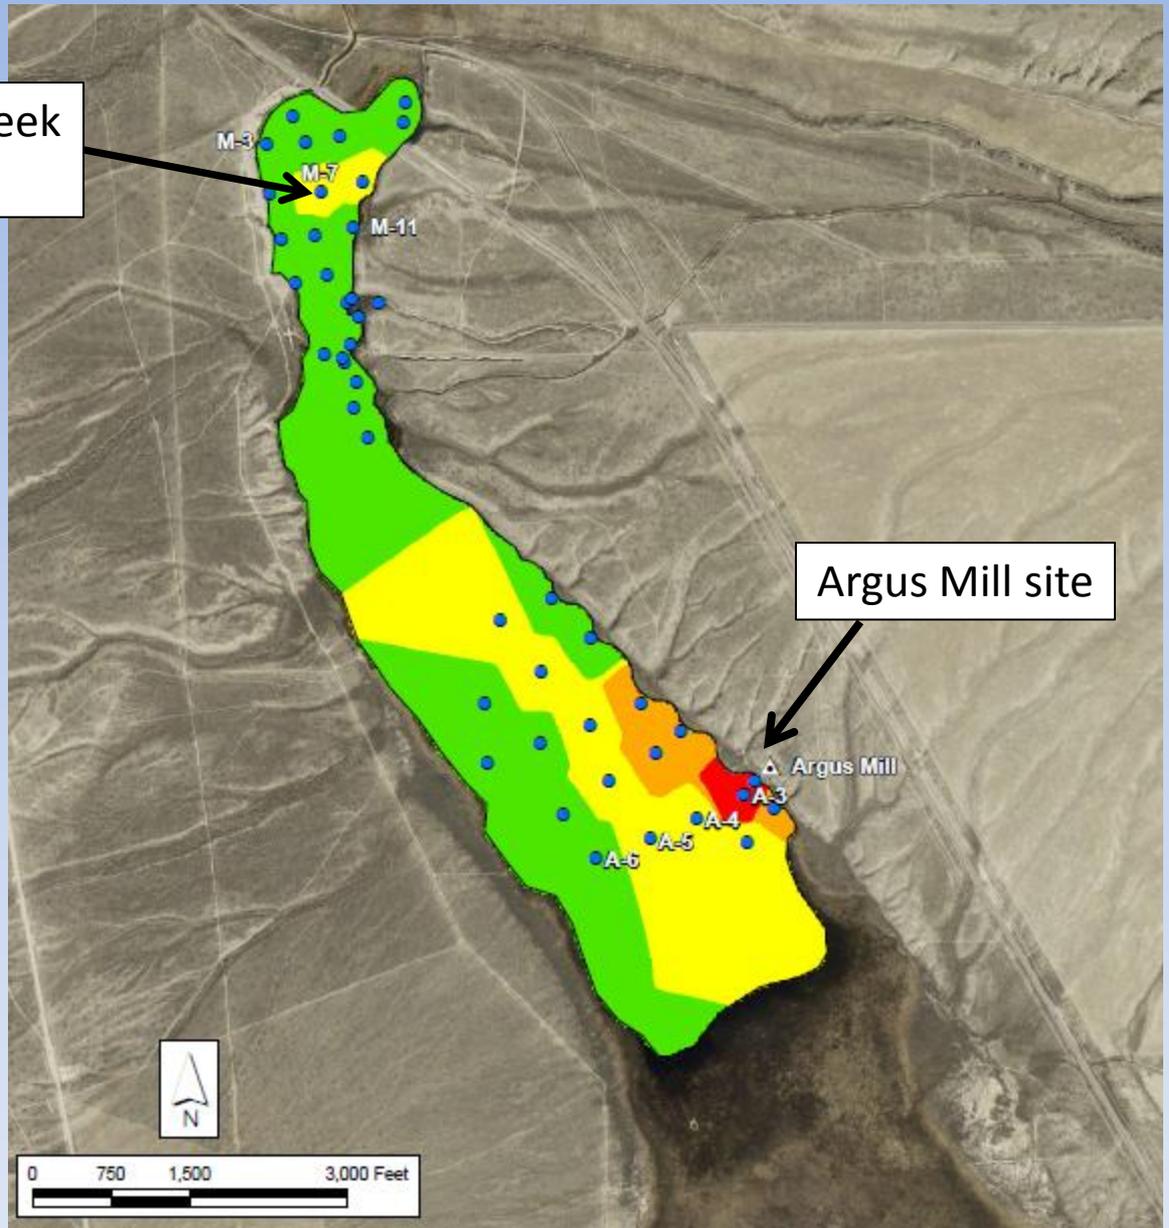
Argus Mill site

● Sediment sample location

Concentration in nanograms per gram

Green	11.6 - 999
Yellow	1,000* - 9,999
Orange	10,000 - 99,999
Red	100,000 - 509,000

\* = Potential action level

Additional soil and reservoir substrate sampling was conducted by NDEP/ EPA in 2008 and a comprehensive study was initiated examining soil and substrates, vegetation, macroinvertebrates, plankton, water, and fish to determine where and how the methylation is occurring in Comins Lake, and options for mercury remediation.

The study concluded in August, 2010 and a report was released in September 2011
